Structural Evaluation and Strengthening Strategy for a Reinforced Concrete Commercial/Residential Complex in Northern Beirut

Abstract

1-Background

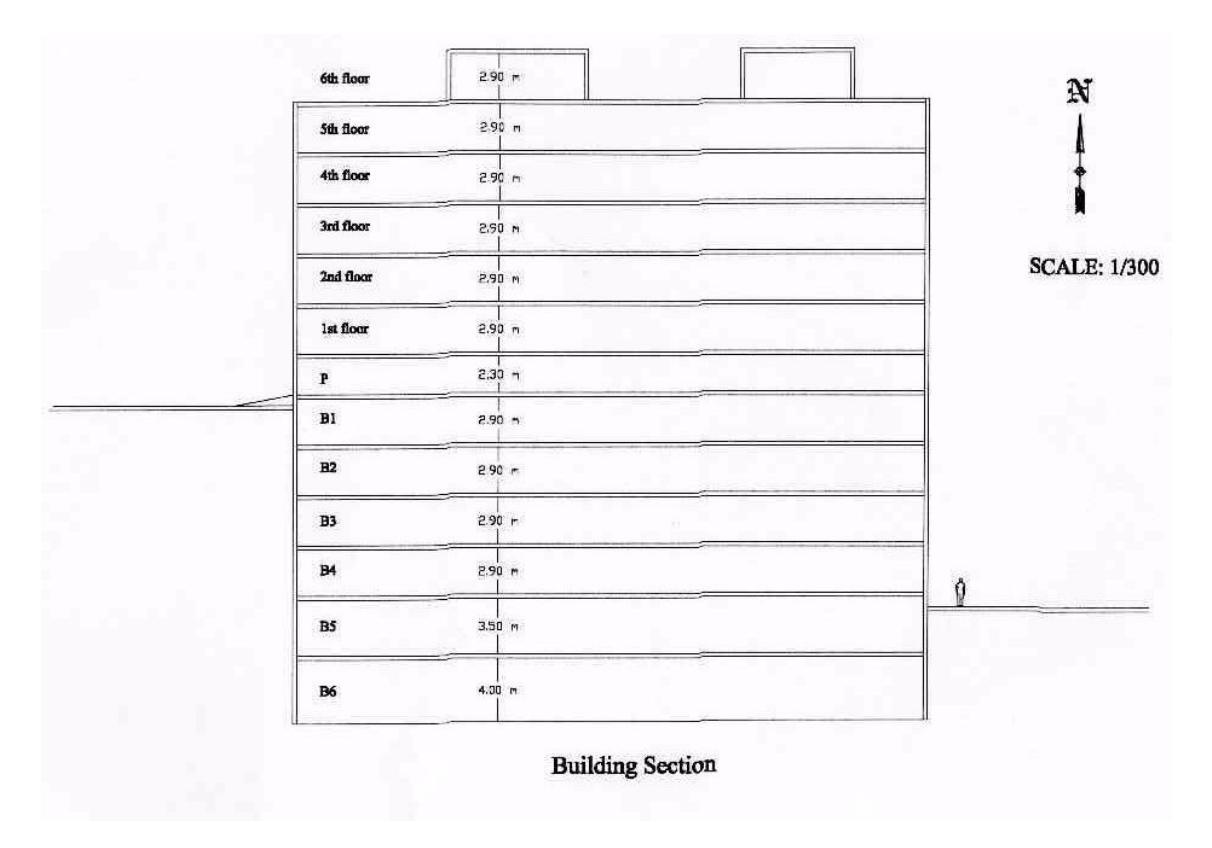
Figure 1. East-West Building Section

The structure was built on a lot between two parallel streets separated by about nine to ten meters in elevation. The original slope from the north-east to the south-west was graded, the structure constructed, and the sides backfilled to restore the streets back to the levels of the municipal urban plan (ref. to Figure 1). A total of thirteen slabs were built with six basements from the upper level street (two from the lower level street). The lower three basement floors were used industrially by a furniture factory, a sewing shop, and for paper and charcoal storage. The upper residential six story building is supported on a ground floor of "pilotis" or unbraced columns, to allow for covered street level parking. Small to medium cracks had been reported by occupants especially in the one way ribbed slabs of the lower underground floors.

f-asymetric earth loading conditions on the structure with the northern and eastern sides backfilled to higher levels than facing sides.

c-removal of some asymmetrically applied lateral loads by excavating an area of 5x18x6m on the upper northern side of the building, in order to reduce temporarily the lateral earth pressure on the structure.

2-Reduce or remove all together the asymmetric earth lateral load by excavating the northern side, and anchoring or strengthening the upper eastern side.

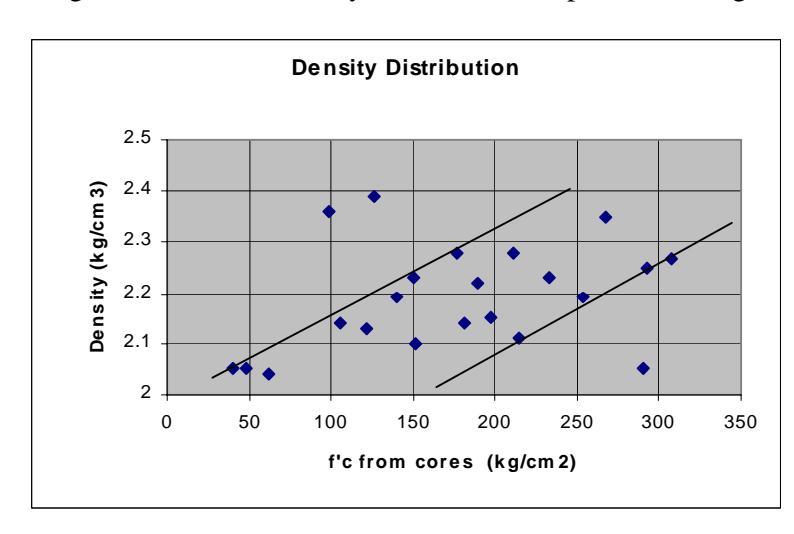
Figure 2. Concrete density versus core compressive strength

Figure 2 shows the density of cores vs compressive strength, and Figure 3 shows the Schmidt Hammer concrete strength versus core compressive strength with the site calibration factor of 0.6 being the slope of the line bisecting the fan shaped distribution of the results. The site calibration line leaves above it as many data points as it leaves below it.

The results showed poor concrete quality throughout with very large variation between different locations. A research of the general conditions during the construction of the building showed that no quality control was performed at the time, and that there were large variations between different concrete batches.

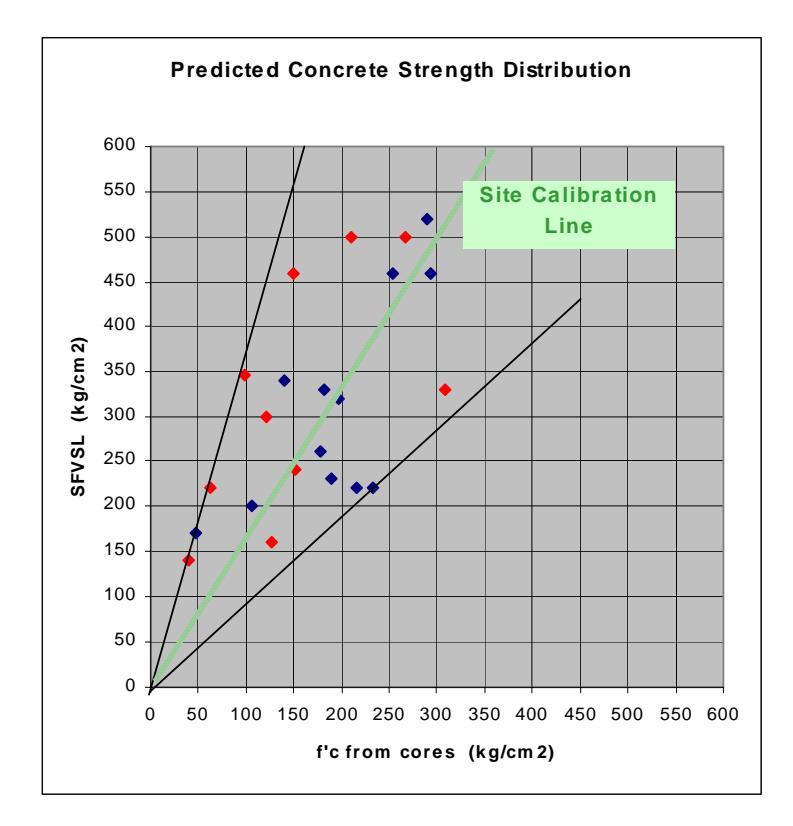
Figure 3. Schmidt Hammer vs core compressive strengths

Additionally five Schmidt Hammer rebound numbers were averaged at each of 120 locations, including those where cores were obtained. A calibration of the Schmidt Hammer results against the results of the cores was used to develop a general picture of the concrete strength distribution throughout the building. The relationship used to obtain the equivalent core concrete compressive strength f'c from the Schmidt Hammer was:

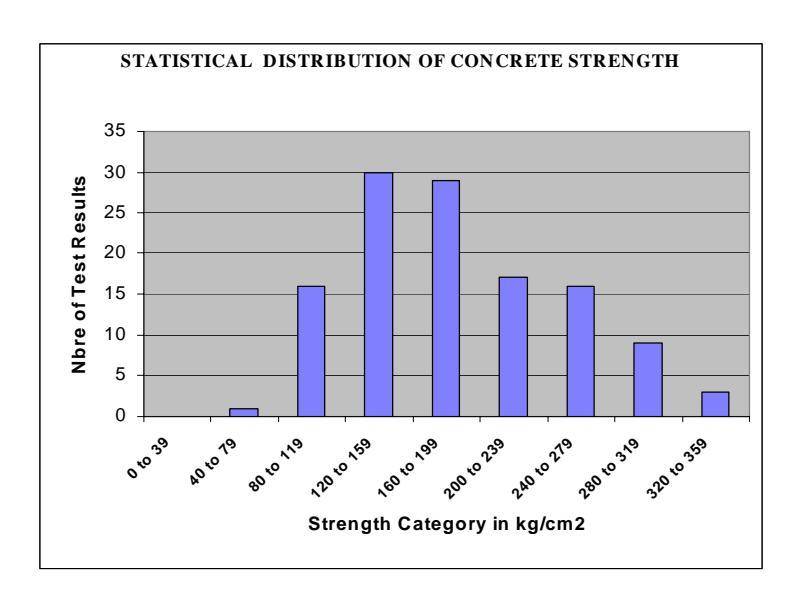
The distribution of the compressive strength results is presented in Figure 4. The average value was 227.55 kg/cm², the median was 180 kg/cm², and the standard deviation was 63.26 kg/cm².
