HOW THE “BIREH” LANDSLIDE QUIT MOVING

Marc Ballouz

Abstract: Every year, a recurring landslide damages a portion of the road stretching about 50m in Bireh, north of Lebanon. This has led to many car accidents and injuries in addition to costly damages to the infrastructure and power lines. Several attempted remedial procedures proved to be inefficient over the past five decades.

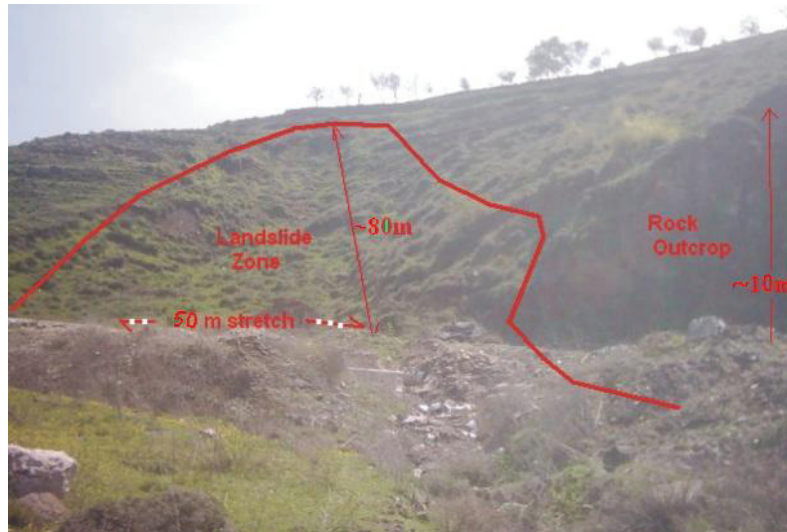
Figure 1. General View from North Side (see Figure 3)

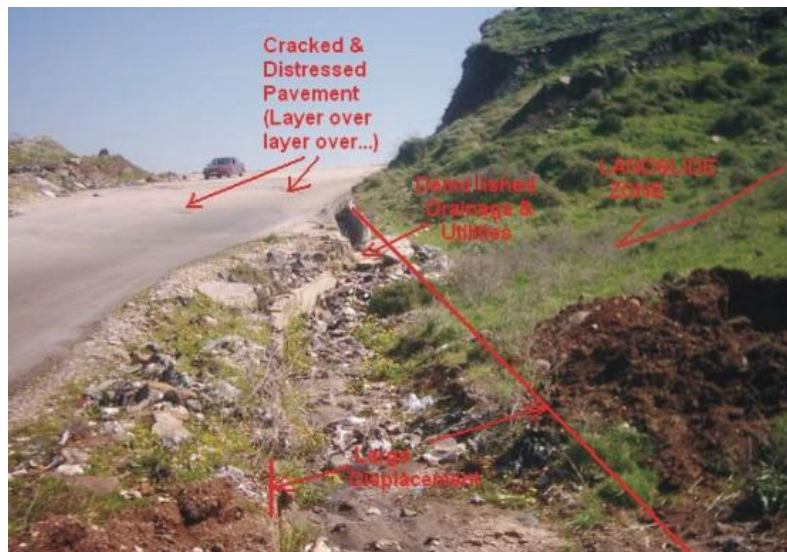
Figure 2. View from West Side (see Figure 3)

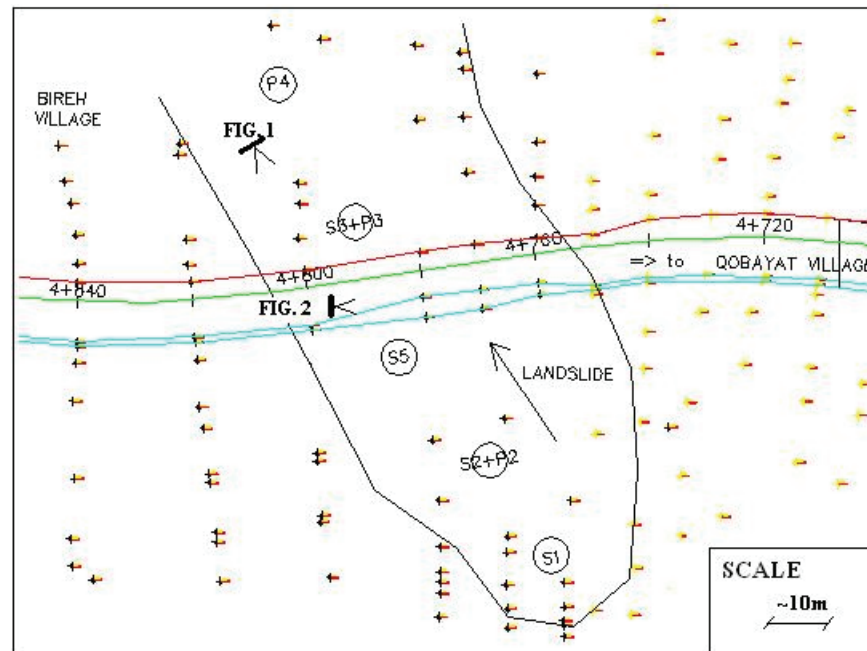
Figure 3. Plan View of Landslide Area

The site is located in Northern Lebanon, about 30 km north of Tripoli. The geological formation in this region is a dolerite Basalt deposit of the Pliocene era. A soil investigation was conducted by SOMECA with 5 boreholes taken along the landslide centerline, 3 above and 2 below the main road, as shown in the plan view of Figure 3, with depth varying from 10 to 12 meters. The P on Figure 3 designates the exploration being done with Cone Penetration Test, and S designates drilling with coring and in situ pressuremeter testing. Three layers were detected: 1- silty clay (3 to 5m), 2- conglomerate of basalt fragments and clayey sand (8 to 10m), and 3- basaltic bedrock. Under the road it seems that about 5m of gravelly backfill had been installed in the past and in stages to level the displaced road. Lab and in-situ testing provided insight to the soil parameters and characteristics, with representative values shown in Table 1.

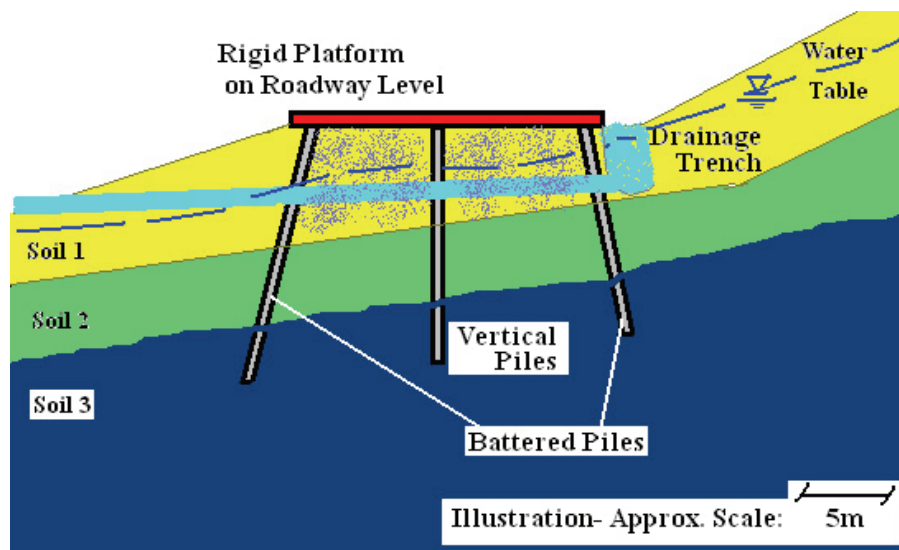
Figure 4. Proposed Solution

With the limited budget available, the challenge was to find an optimized solution within the right of way limits since adjacent terrains are private lots and could not be altered. The solution should be capable of resisting the lateral forces of the landslide as well as the vertical loads of the roadway traffic. The solution proposed by is illustrated in Figure 4 and consisted of actually nailing the top weak soil layers to the lower strong strata. This can be achieved by using a combination of battered and vertical piles, connected by a rigid platform at road level, and complemented by a drainage system. This multi-directional approach gives a hidden redundant safety that might be needed under extreme conditions. In the author's opinion, when failure is already present such approach is highly recommended. This multi-directional approach had its efficiency proven lately on another similar landslide problem (Rasplicka *et al.* 2004). Additionally, Laudeman *et al.* (2004) demonstrated that multiple rows are more efficient than a single row of piles in resisting slope failure.

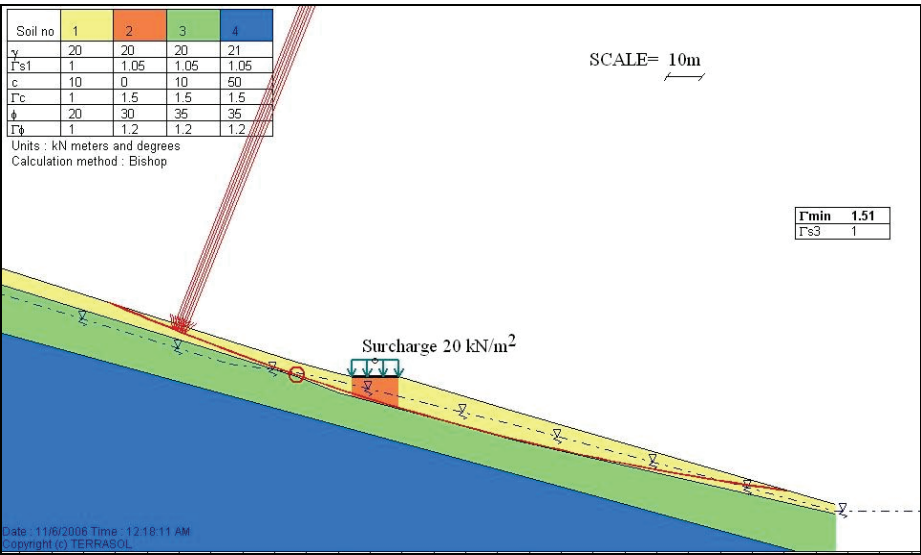
Figure 5. Actual Situation

The initial step was to recreate the present situation with a safety factor close to one representing the slope at the edge of failure. In fact, by recreating the geometry of the slope along the landslide centerline, using the soil parameters presented in Table 1, a model was prepared to represent the actual situation in May 2005 with the water table set at that date. This model is presented in Figure 5. As Figure 5 shows, when setting all the partial safety factors equal to one, the global safety factor ϕ_{\min} obtained was $\phi_{\min}=1.51$. This value indicates that the landslide under unsaturated condition is safe, which was the case in the spring of 2005.

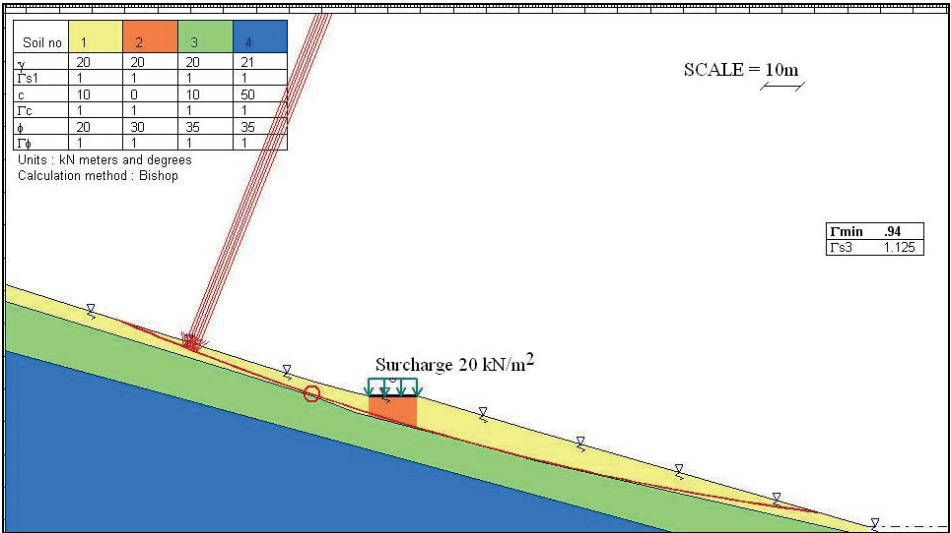
Figure 6. Saturated Condition

Another model was prepared to simulate a storm with heavy rainfall by saturating the slope to the surface. This model is presented in Figure 6. In this model the global safety dropped below the failure envelope with $\phi_{\min}=0.94$; which, theoretically explains why the Bireh landslide is active only after heavy rains, occurring at a transient stage between the conditions presented in Figures 5 and 6. Recently L'Heureux *et al.* (2006) studied this transient flow using numerical analysis for a slope subjected to heavy rainfall in order to investigate a slope failure in Norway. This approach of comparison between actual and critical conditions is also known as a back-analysis approach that permits validating the sensitive variables of the problem like the soil parameters and pore pressures. Slingerland *et al.* (1982), Desai *et al.* (1995), Chen *et al.* (2002), Tiwari *et al.* (2005) and L'Heureux *et al.* (2006), amongst others, have relied on back-analysis methods for solving slope stability problems.

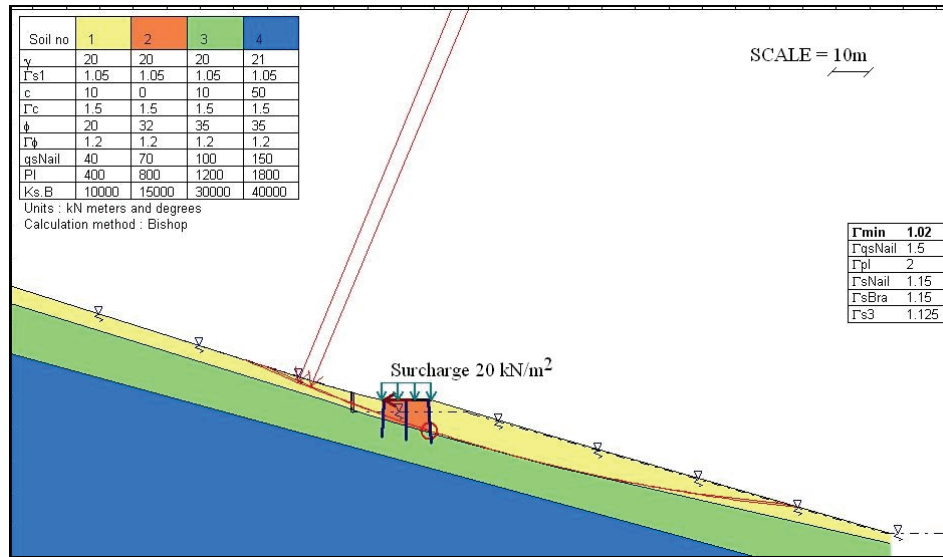
Figure 7. Solution Model under Saturated Conditions

applied and the global stability factor had to exceed the value of $\gamma_{min}=1$. The hunt for the optimal geotechnical design was determined by fixing the pile length, and varying the pile diameter and spacing. The TALREN model was prepared as shown in Figure 7 to represent the optimized solution. Optimization was attained when the global safety fell slightly above the requirement ($\gamma_{min}=1.02$), under the most critical conditions; that is, heavy rainfall and full soil saturation.

The pile length was set as to ensure on site at least 3m embedment into the bedrock layer. According to the initial soil investigation an average pile length of 12m was expected. Assuming a road surcharge of 20 kN/m², a global safety factor $\Gamma_{min}=1.02$ was achieved as shown in Figure 7, with the following support system: 3 rows of 600 mm diameter piles, two of them being battered, with a spacing of 2.5m c/c between piles, all connected at the top by a 400 mm thick slab-on-grade. Also a drainage trench was to be installed towards the uphill side with the role of releasing excess pore water pressures near the roadway and around the support system.

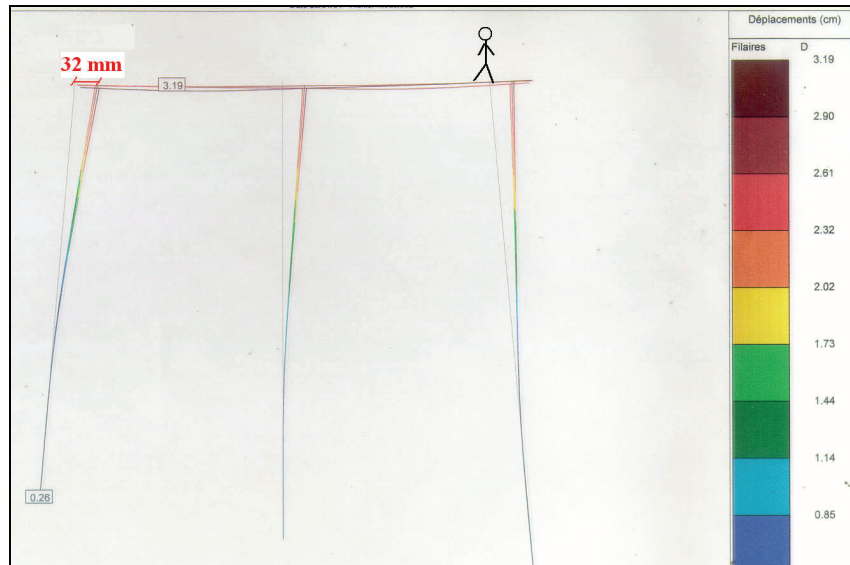
Figure 8. Expected Maximum Displacements

The system was subjected to vertical as well as lateral loading. A structural 2D frame representing a typical section of the support system was considered. This frame was analyzed by the Finite Element method using Arch/Effel structural software. Assuming small strains, the soil and rock material were modeled as elastic springs acting laterally and vertically and attached to discrete elements on the piles. By considering the geometry, the surcharge load, and the lateral earth pressure on the piles, a soil structure interaction behavior was obtained. The output given in Figure 8, shows that under the most critical conditions, the maximum displacement of the structure is in the horizontal direction at the top, and is expected to reach 32mm. Such displacement remains within tolerable limits for piles that are 12m long. As supplemental information, the expected moment diagram for the structural system is presented in Figure 9.

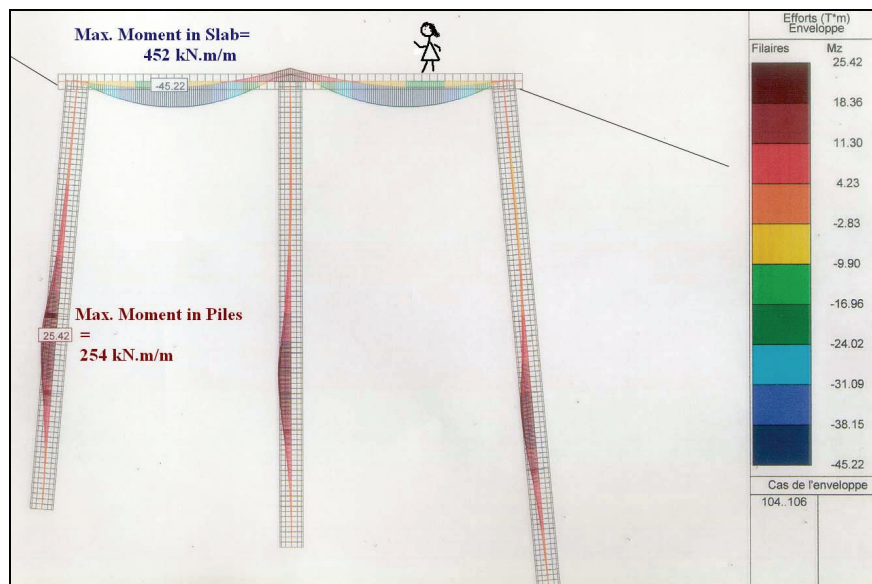
Figure 9. Expected Moment Diagram under Critical Conditions

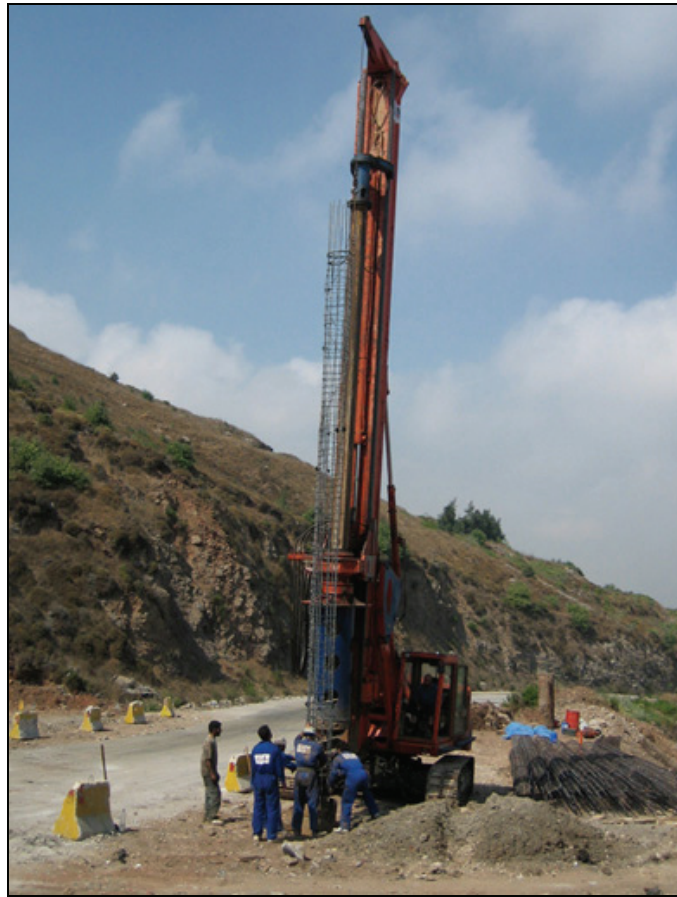
Figure 10. Pile Installation

The piles were installed using a Soilmec R10 Drill rig shown in Figure 10. The pile installation went smoothly with little construction difficulties except for the discovery of very deep bedrock within the landslide zone. This was unexpected and led to the belief that actually the Bireh landslide is nothing but a volcano crater filled with erosion deposits with weak shear strength characteristics, ready to slip when saturated. A graphic representation with a plan view and section view of the 3 rows of piles is given in Figure 11. The different soil layers

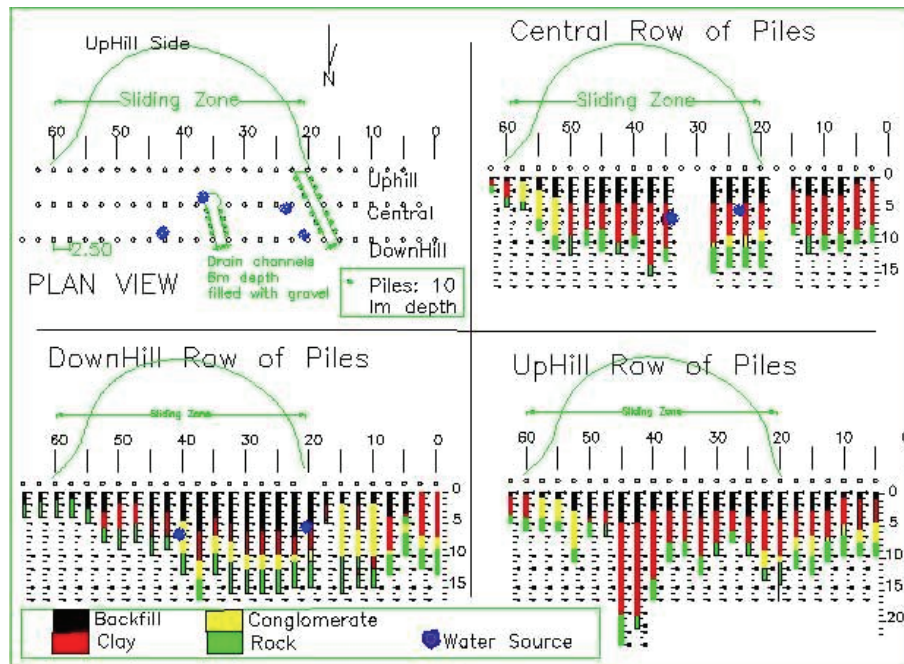
Figure 11. As-Built Drawings of Pile Support System

encountered during drilling are also indicated in Figure 11, where the varying bedrock depth delimiting the landslide is apparent.

It should be noted that four underground water sources were discovered during the pile drilling operations as shown in Figure 11. These water sources were found at a depth of about 5m below the road level. This discovery proved that the 5m deep drainage trench on the uphill side played its role.

structural element, bridging horizontally above the landslide zone as shown in Figure 11, is believed to have provided extra rigidity to the landslide support system for the Bireh road. This extra rigidity may have provided an extra hidden safety in the solution. The performance of the support system will be monitored for the next 5 years. Already this year the slope has been soaked with the first rains of its second winter season 2006-2007... without a problem!

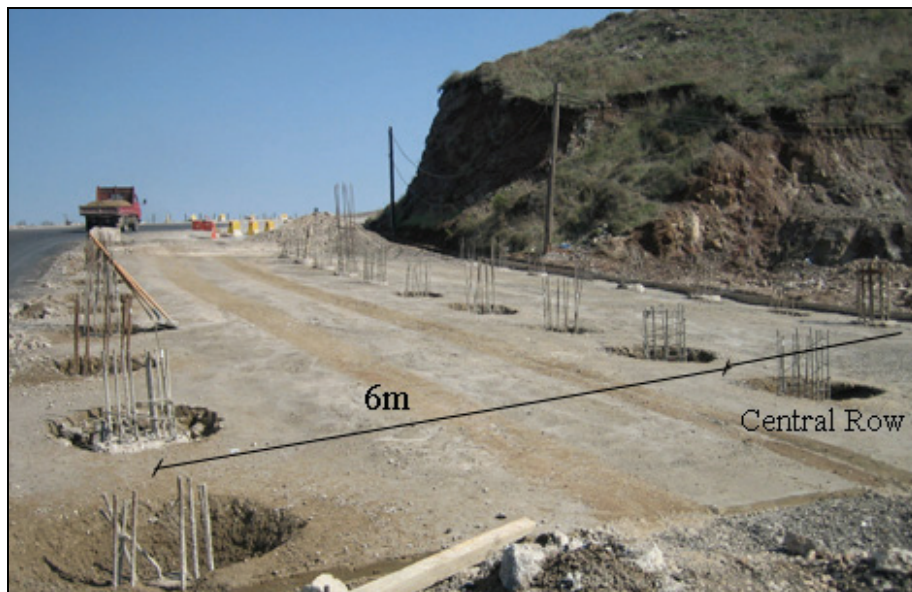
Figure 12. Final Layout of the Piling System

After the pile installation, the pile heads were cut-off and the grade preparation put in place. This phase of the construction is shown in Figure 12.
